Manhole Inspection Summary

Manhole # S25M__003MH

Insp Date: **3/5/08 10:10 AM**

Location Address: **1301 Herkimer Street**

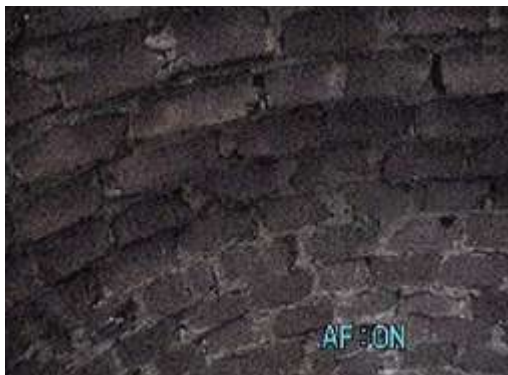
Condition: ☐ Sound ☒ **Cracked** ☐ Root Intrusion ☐ Loose Brick ☒ **Deteriorated**

Corbel deterioration and infiltration

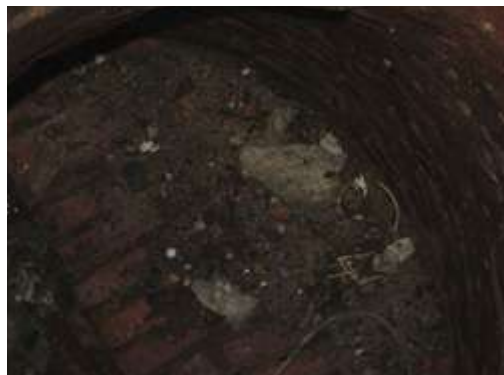
Condition: ☐ Sound ☐ Cracked ☐ Root Intrusion ☐ Deteriorated ☐ Leaks ☒ **Debris**

debris on bench

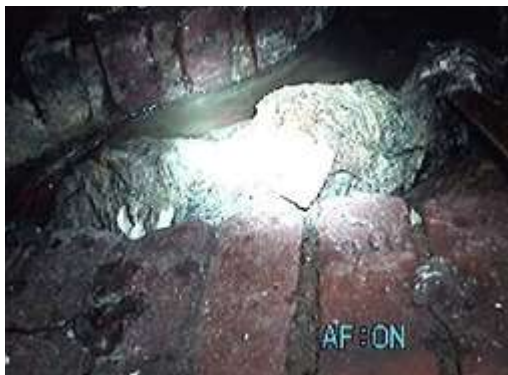
Defect 7

missing mortar and signs of infiltration

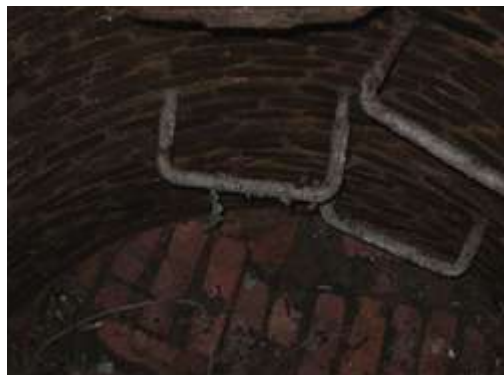
Defect 5

debris on edge of channel and bench

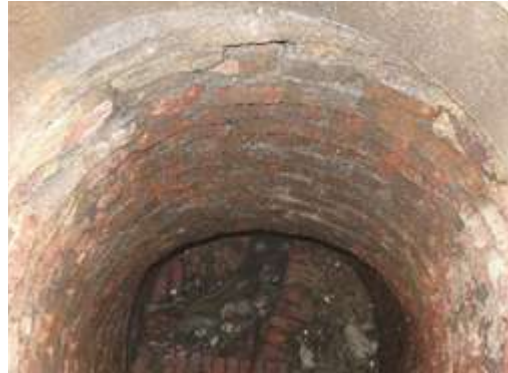
Defect 4

Frame Offset: **2** (in.) Condition: ☒ Sound ☐ Cracked ☐ Leaks

frame offset

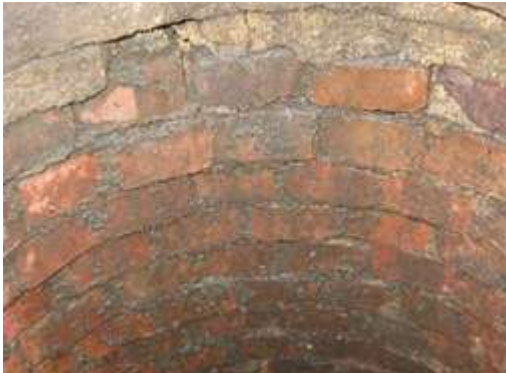
Defect 3

moisture on wall sign of infiltration in Corbel

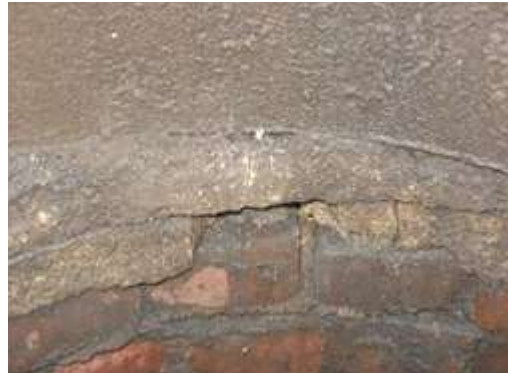
Defect 2

moisture on walls of manhole sign of infiltration in corbel

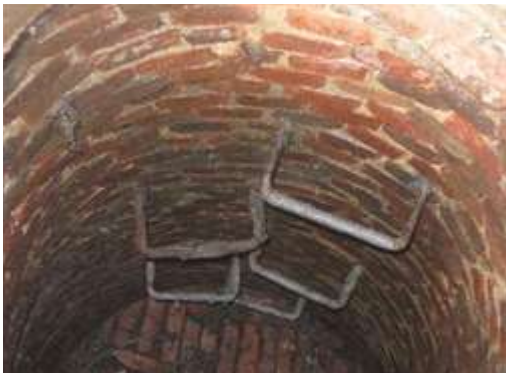
Defect 1

missing mortar and signs of infiltration in chimney

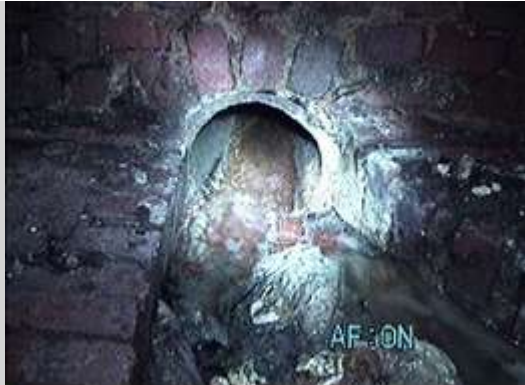
12 O'Clock Outflow

Pipe Height: **8.4** (in.) Rod and Bar (Angled)
Pipe Material: **Clay** ☐ Pipe Lined
Invert Depth: **10.83** (ft.) Flow Characteristics: **Fast**
Deposits: ☒ None ☐ Mud ☐ Sludge ☐ Debris ☐ Grease
Silt Depth: **0** (in.) Deposits Extent:
Infiltration: **None** Pipe Seal Cond: **Sound**

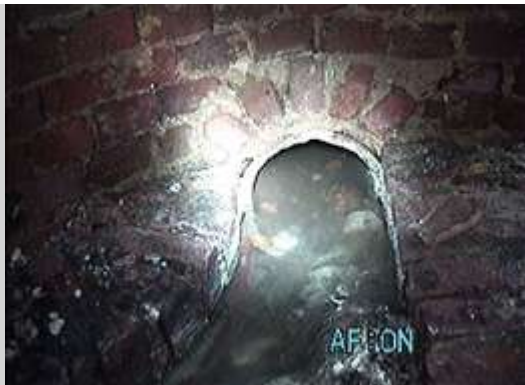
3 O'Clock Inflow

Pipe Height: **8.4** (in.) Rod and Bar (Angled)
Pipe Material: **Clay** ☐ Pipe Lined
Invert Depth: **10.86** (ft.) Flow Characteristics: **Slow**
Deposits: ☒ None ☐ Mud ☐ Sludge ☐ Debris ☐ Grease
Silt Depth: **0** (in.) Deposits Extent:
Infiltration: **None** Pipe Seal Cond: **Sound**
